2014 Annual Inspection Report

**Barataria Bay Waterway West
Shoreline Protection**

State Project Number BA-23
Priority Project List 4

July 7, 2014
Jefferson Parish

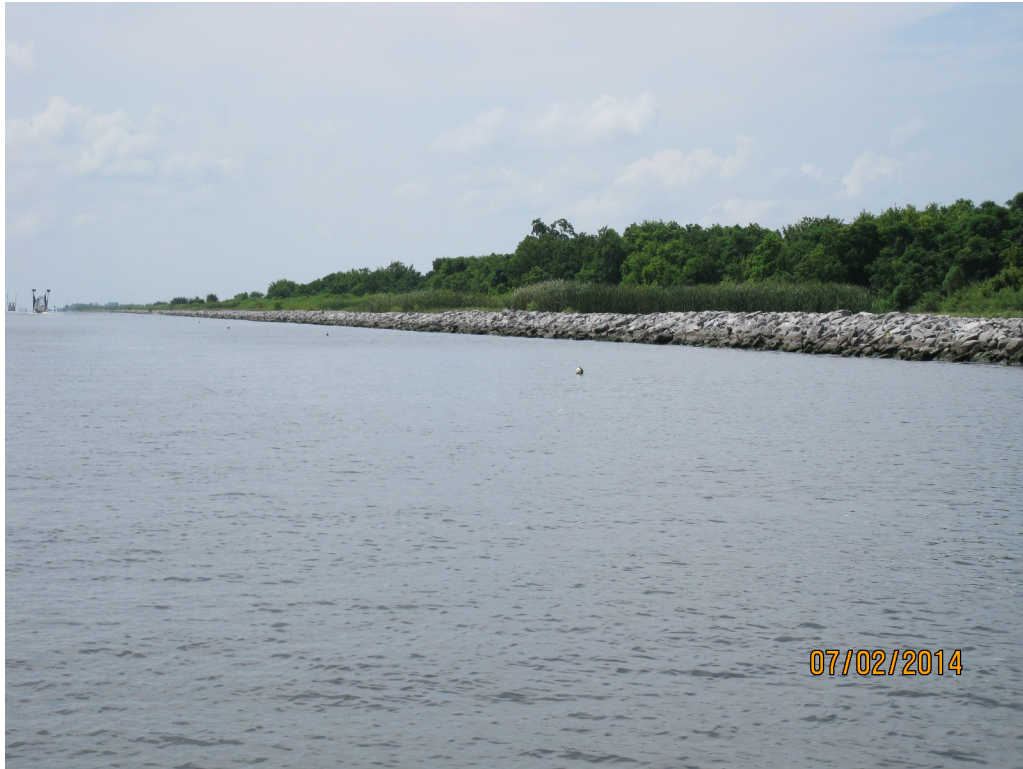
The rock structure appeared to be in good condition at the time of the inspection (Photo #1). There are some sections which have experienced settlement, but the structure is still functioning as designed. These sections will continue to be monitored for maintenance needs.

Photo #1 – Shoreline Protection

- Continue to check the water control structure during operational procedures.
- Continue to observe rock structure for settlement.

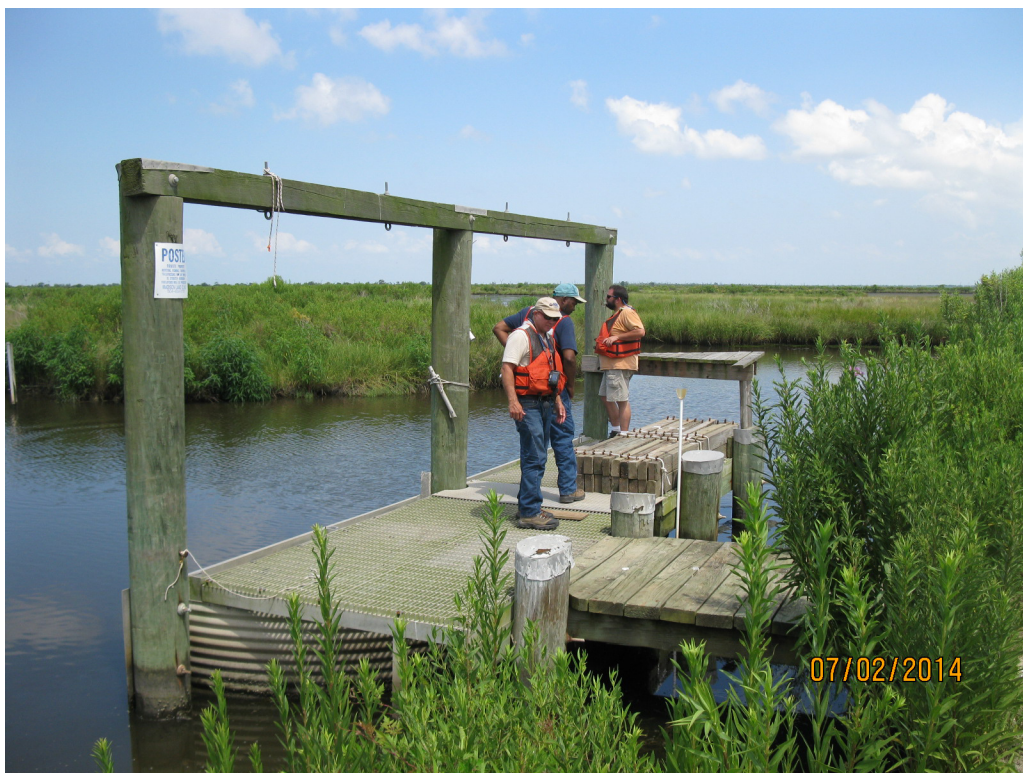
The structure was operated according to the operations plan; stop logs had been removed from the weir and stored on the structure (Photo #2). Significant erosion was observed on the berm covering the culverts (Photo #3). This may be the result of standard tidal erosion; however, there is some evidence that this could also be coupled with burrowing wildlife (Photo #4).

Photo #2 – Water Control Structure

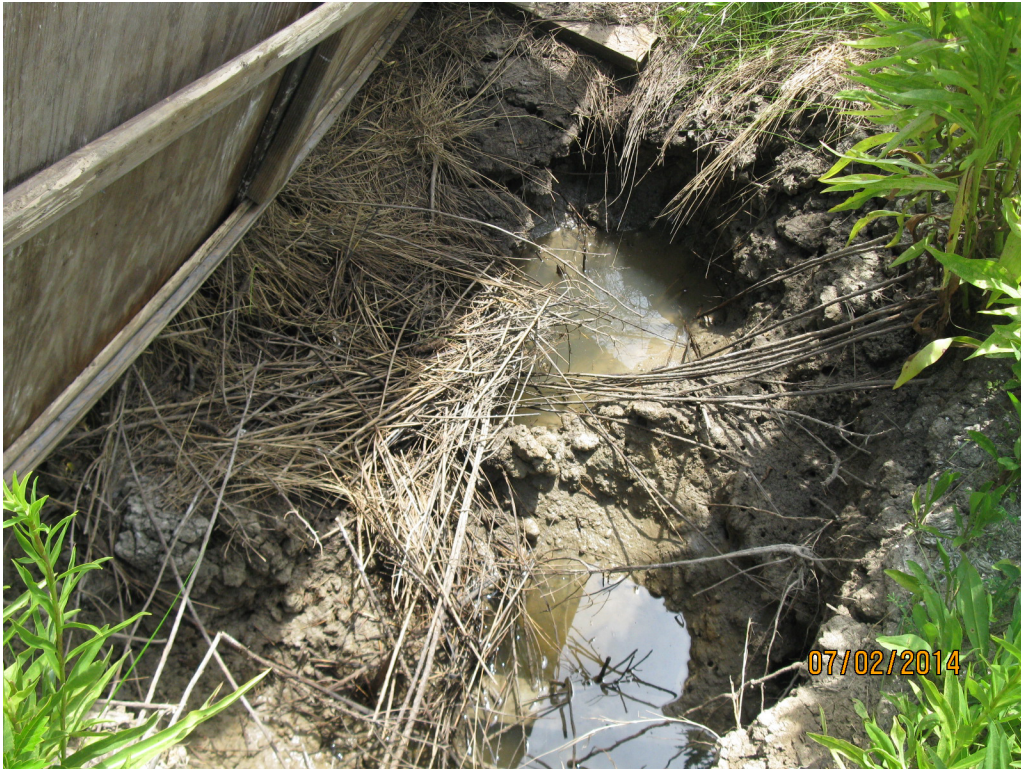
Photo #3 – WCS Berm Erosion Above Culverts

It is recommended that the berm over the culverts of the Water Control Structure be repaired using fill excavated from within the project site. It is also recommended that rip-rap erosion control be considered to ensure long term success of this feature. CPRA will design the repair and continue to work with NRCS to affect these repairs.

- Repair erosion of berm over culverts of Water Control Structure.

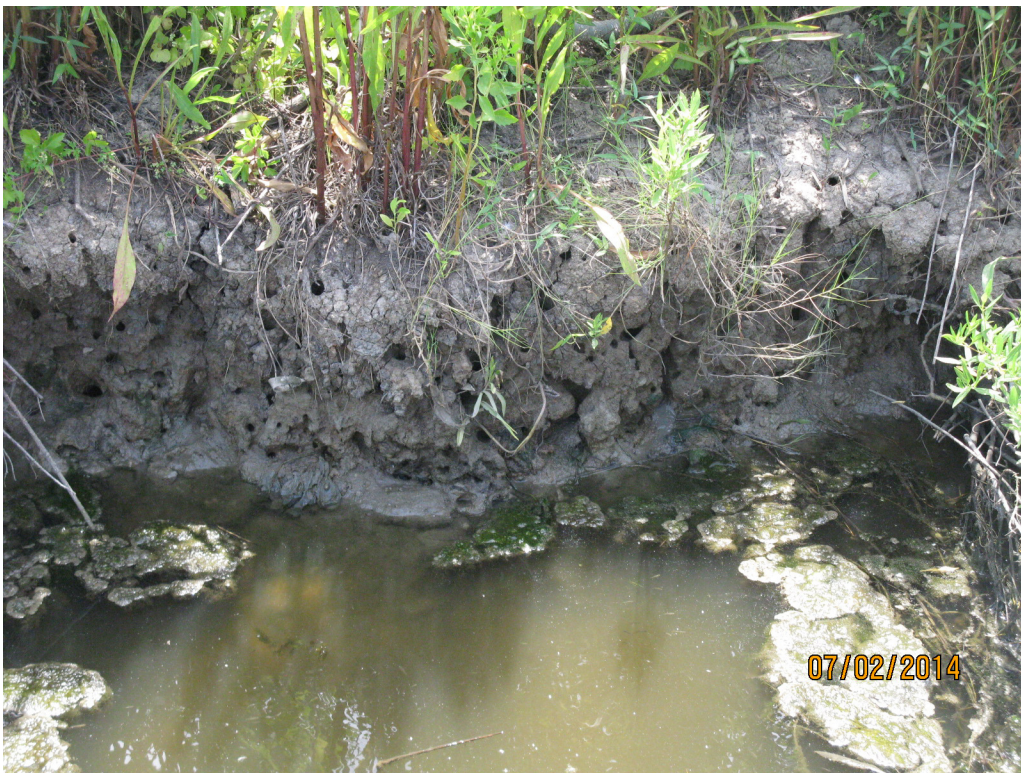
Photo #4 – Erosion/Apparent Burrowing in WCS Berm
